# West Virginia Covered Bridges Survey and Restoration

## Background

## Scope

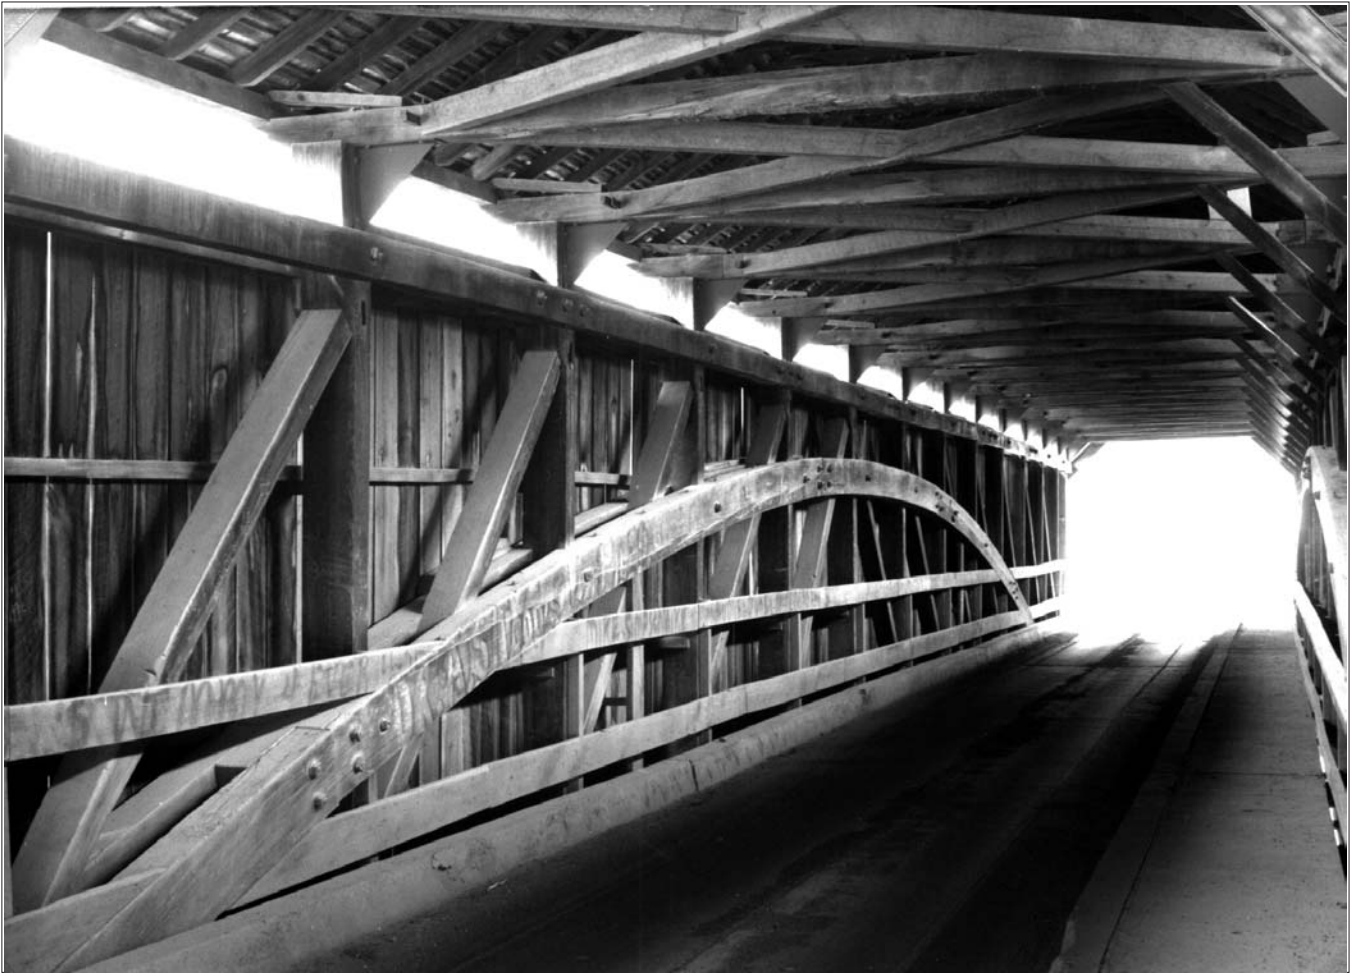
***Clockwise from top:** Carrollton Covered Bridge, Barbour County, interior west wall showing multiple king post and Burr arch truss. (IHTIA); Walkersville Covered Bridge, Lewis County, west abutment. (IHTIA); Typical vertical post assemblage, Barrickville Covered Bridge. (Paul Boxley)*
