Fernow Experimental Forest Virtual Tour

**USDA Forest Service
Northern Research Station
Timber & Watershed Laboratory
Parsons, WV**

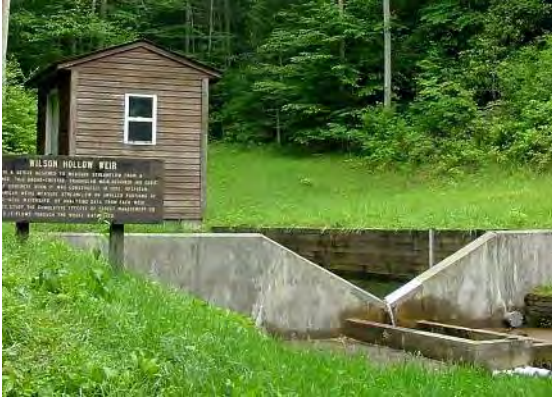
2 Wilson Hollow Weir

This monitoring station, or weir, is measuring streamflow from the largest gauged watershed (325 acres) on the Fernow. The concrete dam (cutoff wall) is anchored to bedrock across the stream channel so that all the water draining from the watershed flows through the control section (V-notch). The weir pond and a stilling well located beneath the weir house are connected by pipes so that water levels can be measured accurately in a

protected enclosure. A digital water-level logger records the height of water every 5 minutes. These measurements enable scientists to determine the quantity and timing of streamflow draining from the watershed.

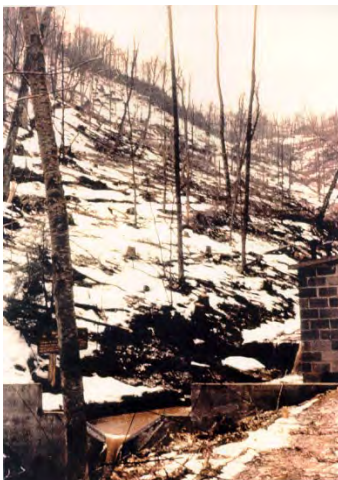
Another stream-gauging station on Watershed 1 is located 100 yards up the trail to the left. A slightly different kind of weir is used at Watershed 1 to measure streamflow because this watershed is much smaller (74 acres) than the Wilson Hollow watershed. Watershed 1 weir was built in 1951. It is one of the 5 original experimental watersheds on the Fernow. In 1957-58, timber stands on four of the watersheds received different cutting treatments, with one watershed designated as an uncut control. Watershed 1 was cut using a "logger's choice" method without the implementation of best management practices to protect water quality. All trees larger than 6 inches in diameter were cut.

One year after harvest

Water quality was seriously impacted during and the first year after logging. Turbidity, a measure of sediment in water, was as much as 2,000 times higher here than on the control watershed. But turbidity improved by the end of year 2, returning to pre-logging levels.

Annual streamflow increased due to logging by 12 to 19 percent during the first three years after harvesting; most increases occurred in the summer. Storm peakflows increased approximately 4 percent while total stormflow volumes increased 13 percent.

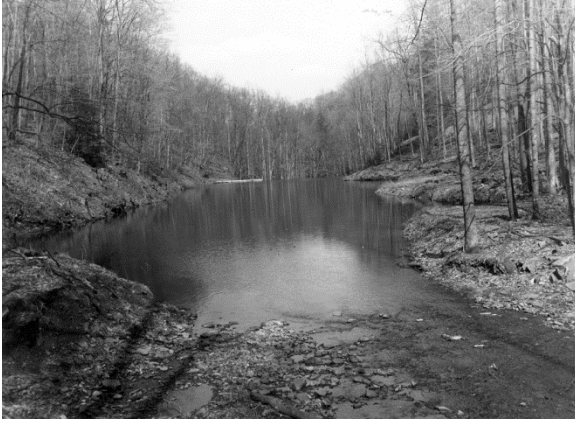
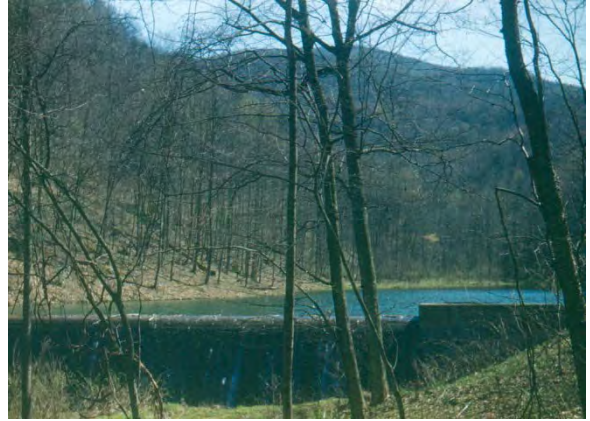
3 Reservoir

Constructed in 1934-36 by the Civilian Conservation Corps, this reservoir was the primary source of water for residents of the City of Parsons until 1996.

During high flows rock and sediment are deposited in the reservoir. The reservoir was emptied and dredged every 10 to 20 years to maintain an adequate water supply.

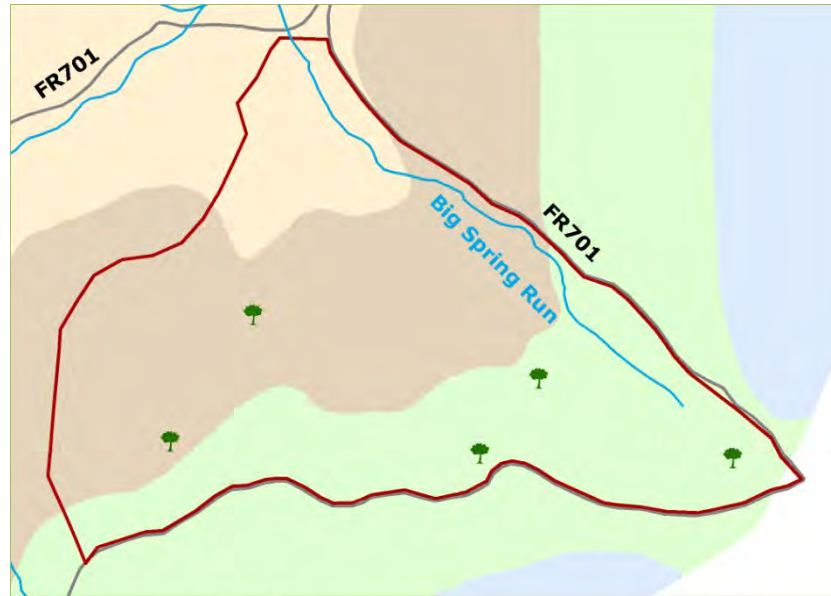
GEOLOGY

- Mauch Chunk Formation - sandstone/shale
- Greenbrier Formation - limestone
- Pocono Group - sandstone
- Hampshire Formation - sandstone/shale

Untreated areas also allow scientists to compare and contrast the effects of environmental factors on forest growth and development. Five plots (tree symbol) were established in the Biological Control Area in 1979 and re-measured in 2009 to track tree growth.

A simple comparison of tree growth by geology shows that the plots on the soils derived from Greenbrier limestone were more productive (growing at a faster rate as shown by the steeper green line) over the 30-year period than plots on the soils derived from Pocono sandstone.

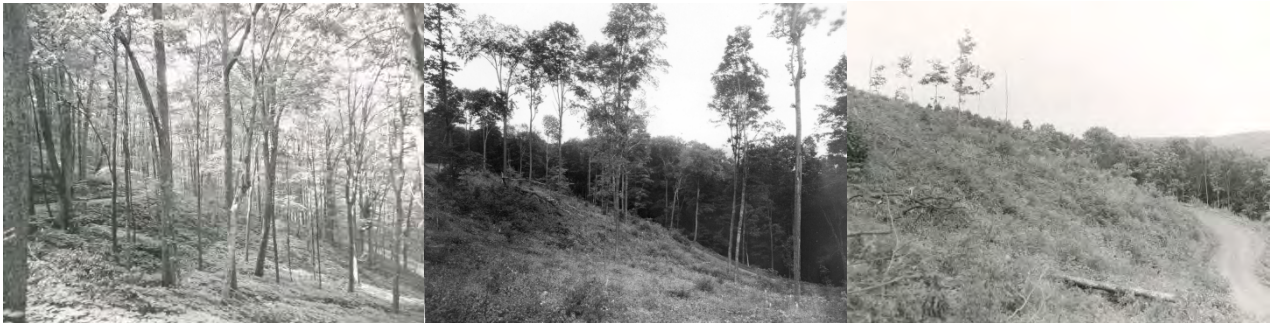
Site before first cut in 1961

Some "seed trees" were left to help provide seeds for natural regeneration

Seed trees were harvested in 1964

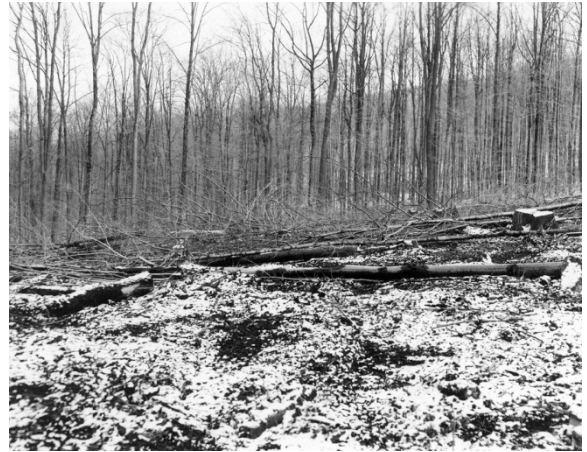
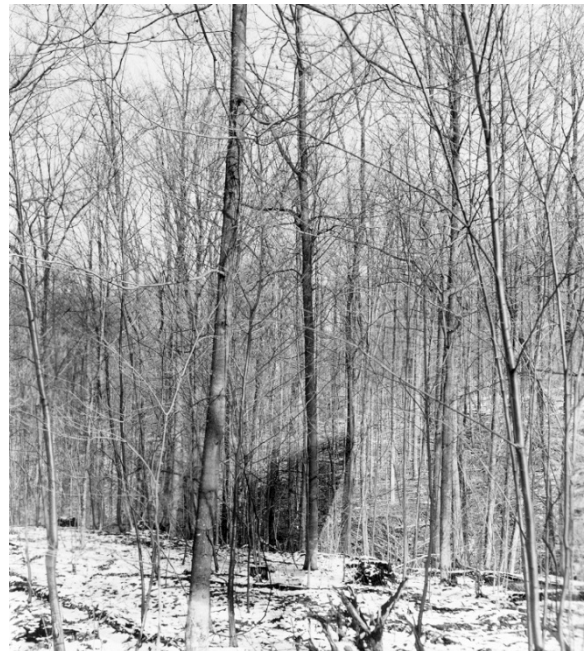
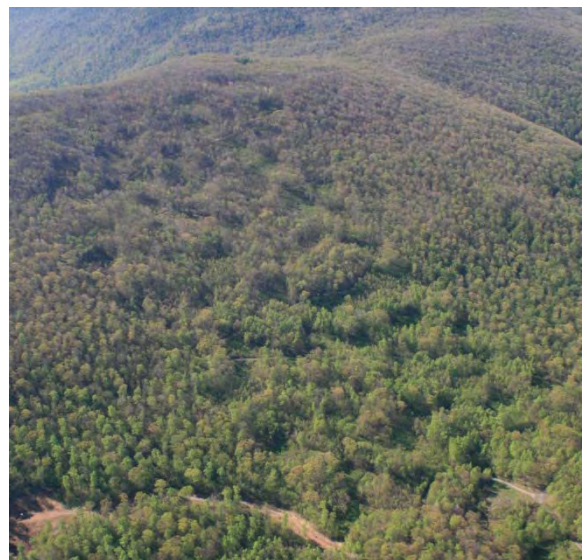
Approximately 4 acres of this 28-acre study area are cut every 10 years. The sixth harvest was made in 2005. After each patch cut a new age class begins to develop. This area has a relatively high density of species, age classes, and vertical strata while maintaining a consistent amount of growing stock (basal area).

Study area (along road) and 2 upslope companion areas seen from the air

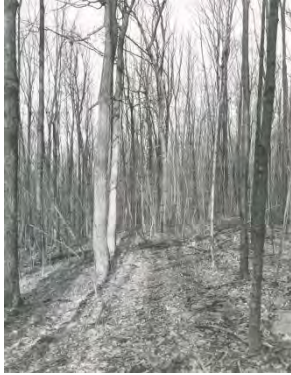
1952 pre-harvest

Uneven-aged management entails maintaining trees of different size classes in the same area. Successful uneven-aged management calls for approximately equal, periodic harvests. Partial cuts are applied here every 10 years.

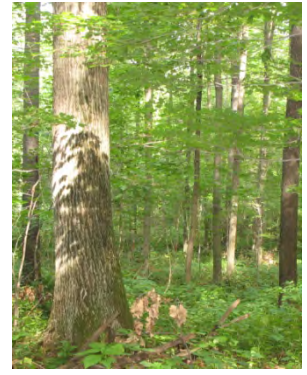
2006 after 6 cuts

Cutting individual trees does not create large enough openings to allow shade-intolerant (light-demanding) trees to become established. Data collected since 1958 indicate that the number of shade-intolerant trees in this stand is decreasing, while there has been an increase in shade-tolerant trees.

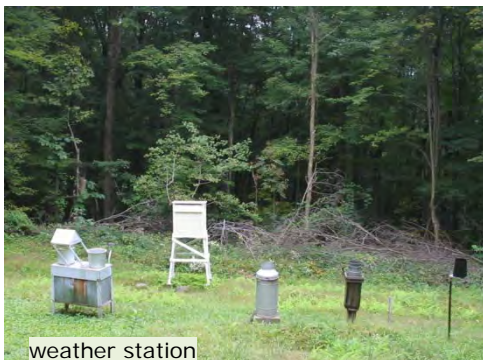
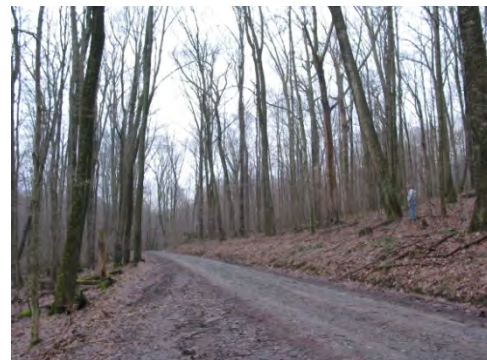
Streamflow is naturally highly variable year-to-year, but differences among treatments still are visible

On the watershed side, water quantity and quality data from this untreated watershed are compared to data from treated watersheds. Scientists can determine the degree of hydrologic change resulting from different treatments as well as changes due to environmental or human-caused factors, such as acid deposition and climate change.

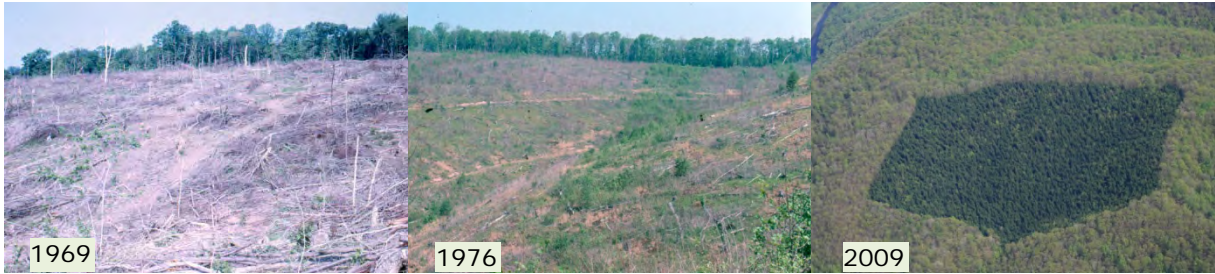
The experiment on this watershed studies the effects of vegetation manipulations on water quantity. The watershed was clearcut in two stages – the lower half in 1964 and the upper half in 1967. Herbicides were used on both halves through 1969 to stop regrowth and determine the maximum streamflow increase that could be induced. In 1973 the watershed was planted with Norway spruce; it is the only area on the Fernow with a predominantly coniferous stand.

Initially streamflow increased after harvesting, primarily during summer. Later, streamflow decreased as the growing spruce stand used more water than the original hardwood stand in the summer, and more snow was evaporated from their canopies in the winter.
